Re: Notice of Violation
Compliance Evaluation Inspection
MND985767482

On April 28, 2015, representatives of the U.S. Environmental Protection Agency and Anoka County, Minnesota, inspected the Eco Finishing Company facility located in Fridley, Minnesota (EFC). As a large quantity generator of hazardous waste, Eco is subject to the Resource Conservation and Recovery Act, 42 U.S.C. § 6901 et seq. (RCRA). The purpose of the inspection was to evaluate Eco's compliance with certain provisions of RCRA and its implementing regulations related to the generation, treatment and storage of hazardous waste. A copy of the inspection report is enclosed for your reference.

Purpose of Inspection: This inspection was an evaluation of ECO Finishing Company, Incorporated's (ECO Finishing) compliance with hazardous waste, used oil, and universal waste regulations found at the Minnesota Hazardous Waste Rules (Minn. R.) and the Code of Federal Regulations (CFR). I performed the inspection with two inspectors from Anoka County. The inspection was an EPA lead Resource Conservation and Recovery Act (RCRA) compliance evaluation inspection (CEI). The site notified as large quantity generator (LQG). The last

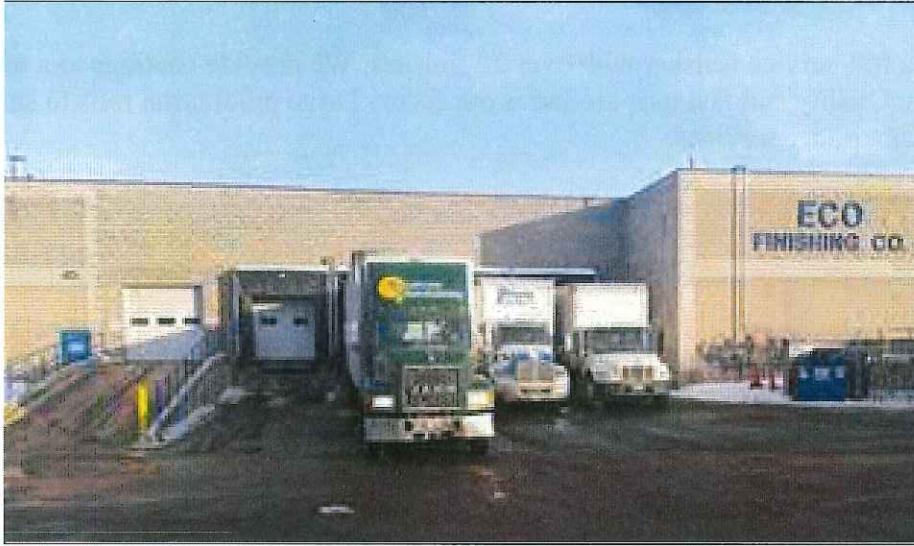
Picture #: SP 1
Date: Unknown
Photographer: Eco Finishing
Location: Outside
Subject: Loading Dock

I included two pictures from the facility's website (Search Picture 1 and SP 2).

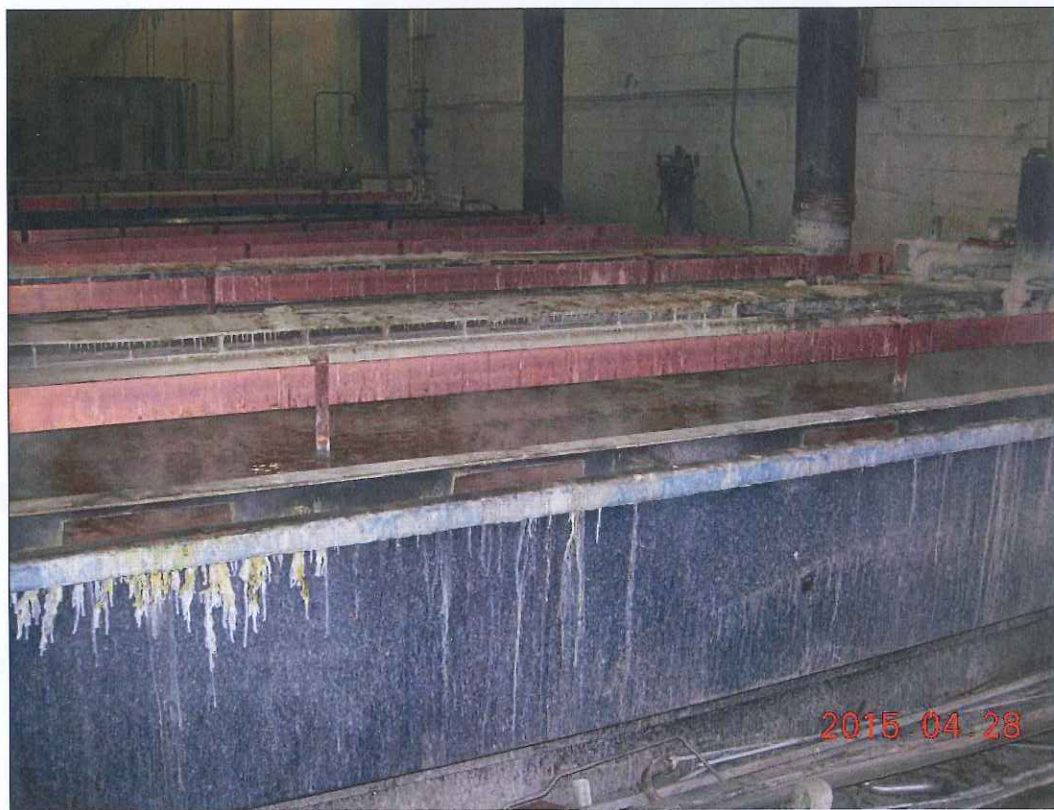
Picture #: 1
(DSCN1148)
Date: April 28, 2015
Photographer: Dan Chachakis
Location: South Facility
Subject: “Big Zinc” plating line

Big Zinc Line: I observed, and took a picture of, what Mr. Madden described as the “Big Zinc Line” (Picture 1).

I looked with a flashlight at the floor under the line and observed the presence of liquid.

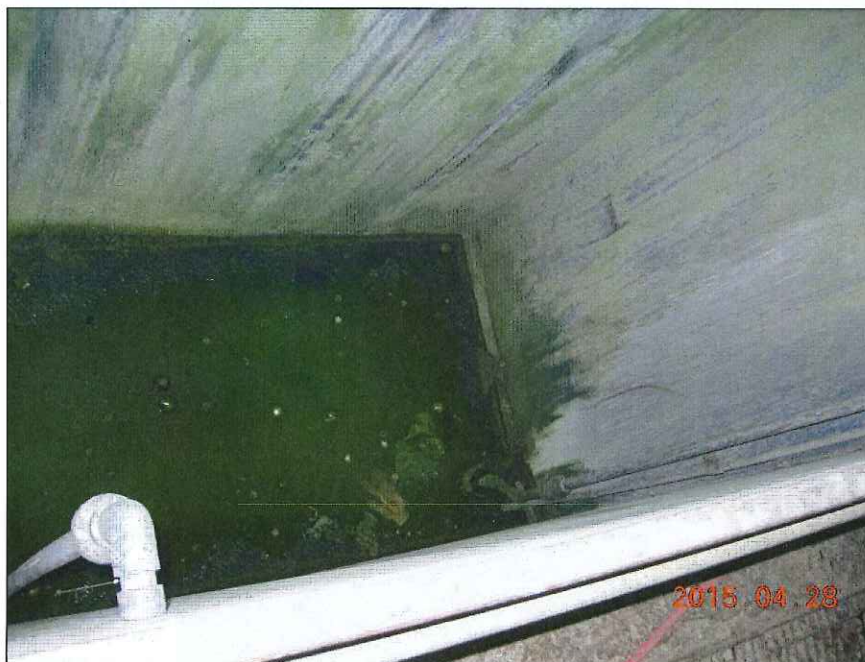
Picture #: 2
(DSCN1149)
Date: April 28, 2015
Photographer: Dan Chachakis
Location: South Facility
Subject: "Big Zinc" plating
line sump

I observed, and took a picture of, a sump (Picture 2). Mr. Madden explained that the sump is part of the wastewater treatment system. This is a point where workers remove liquids accumulated under the line.

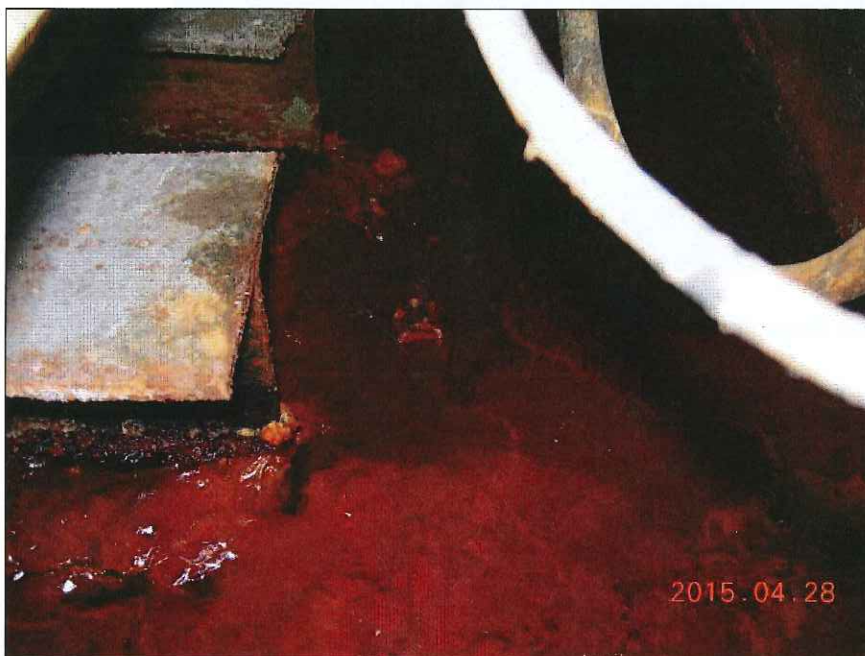
Picture #: 3
(DSCN1150)
Date: April 28, 2015
Photographer: Dan Chachakis
Location: Barrel Zinc Line
Subject: Under the line

Barrel Zinc Line: I observed, and took two picture of, material under the zinc line (Pictures 3 and 4).

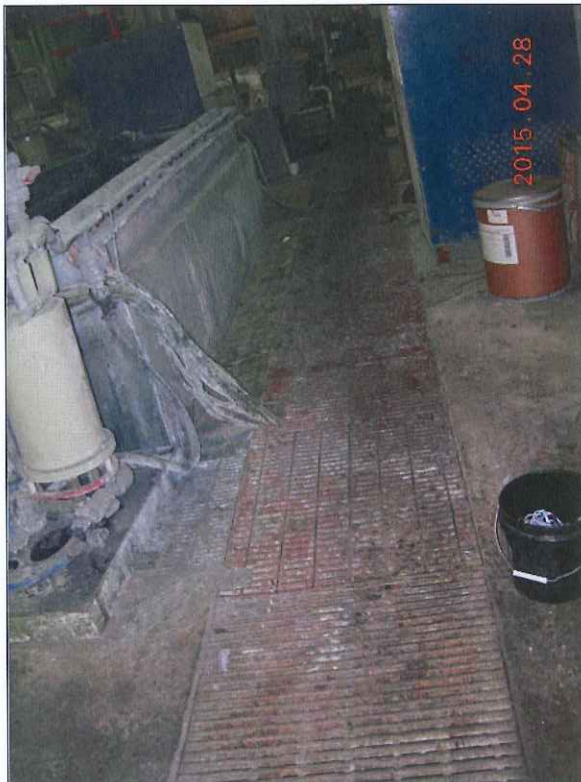
Picture #: 5
(DSCN1152)
Date: April 28, 2015
Photographer: Dan Chachakis
Location: Small Zinc Line
Subject: Grated sump

Small Zinc Line: I observed, and took a picture of, a grated sump (Picture 5). Mr. Madden stated that the sump drains to the basement (Picture 5).

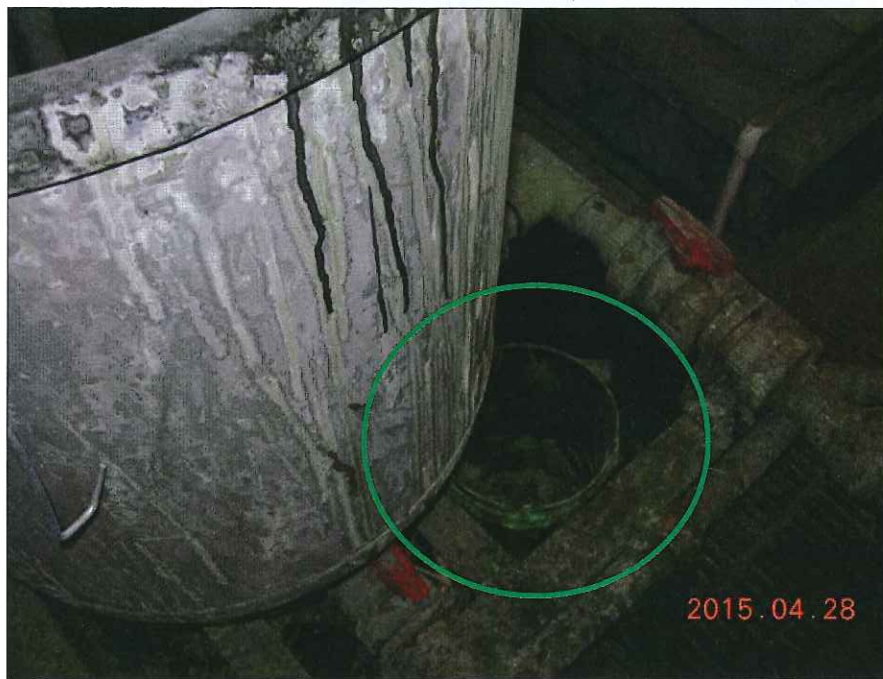
Picture #: 6
(DSCN1153)
Date: April 28, 2015
Photographer: Dan Chachakis
Location: Nickel Line
Subject: Bucket of waste

Nickel Line: I observed, and took a picture of, a bucket that Mr. Madden stated was holding nickel solid waste from the Nickel Line (Picture 6).

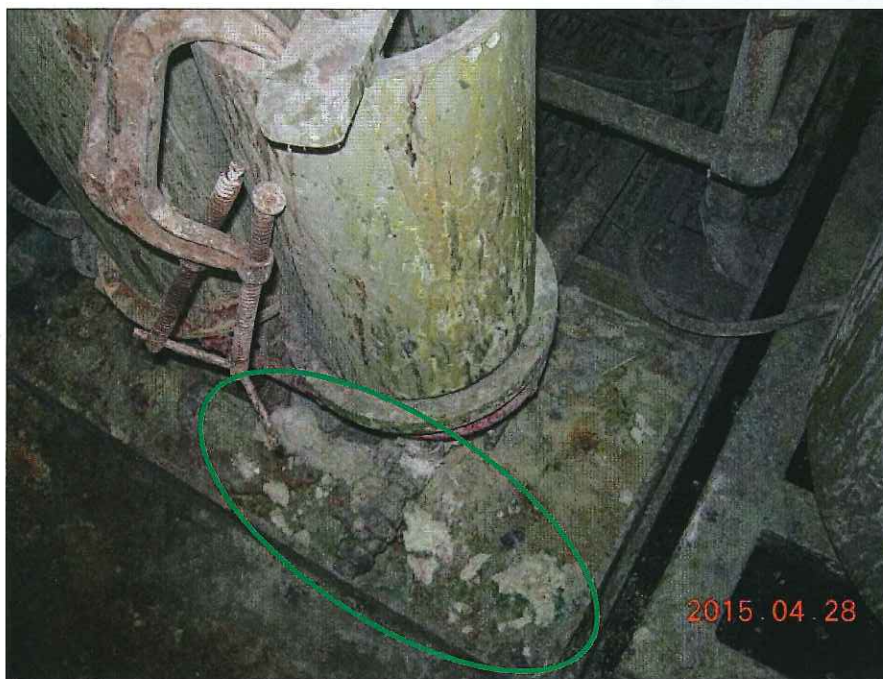
Picture #: 7
(DSCN1154)
Date: April 28, 2015
Photographer: Dan Chachakis
Location: Nickel Line
Subject: Accumulation of white material

I observed, and took a picture of, white material in a secondary container (Picture 7). Mr. Madden stated the material was most likely sodium carbonite.

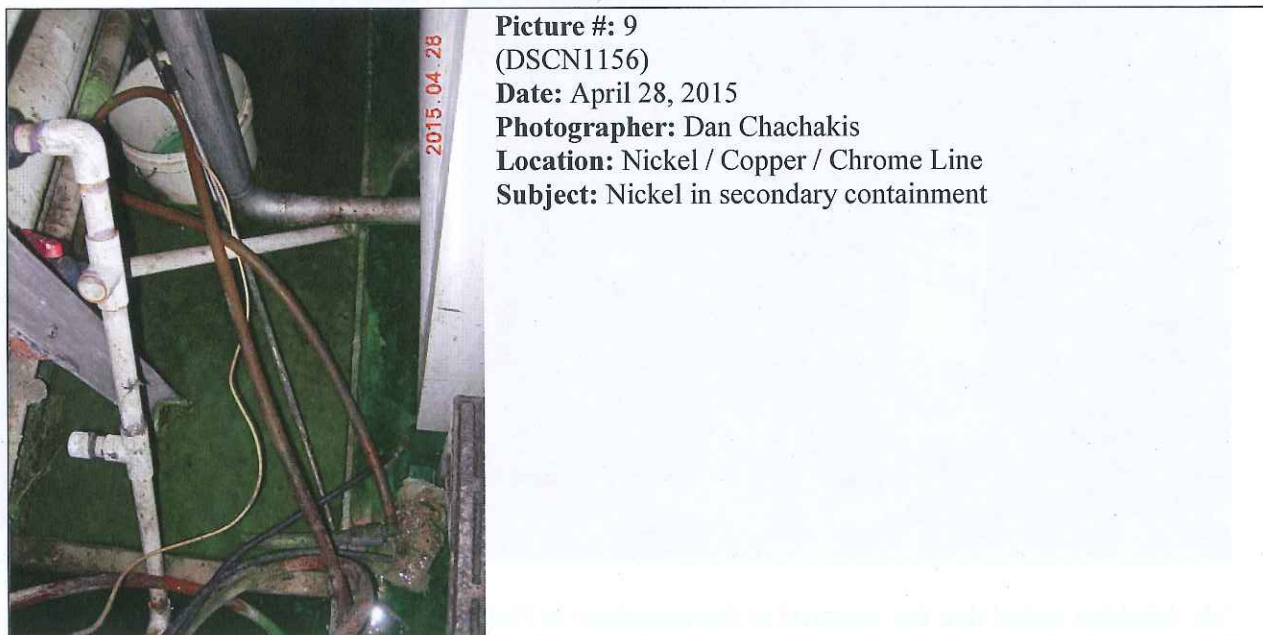
Electrolysis Nickel Line: I observed, and took a picture of, nickel in containment (Picture 9).

Mr. Madden stated that the material in containment in Picture 9 goes to the wastewater treatment system.

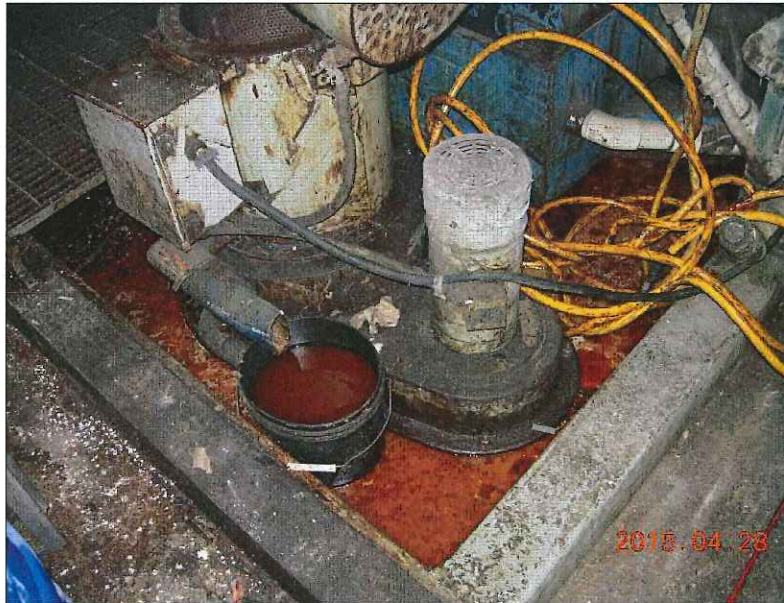
Picture #: 10
(DSCN1157)
Date: April 28, 2015
Photographer: Dan Chachakis
Location: Black Oxide Line
Subject: Accumulation of brown material

Black Oxide Line: I observed, and took a picture of, brown material in containment (Picture 10).

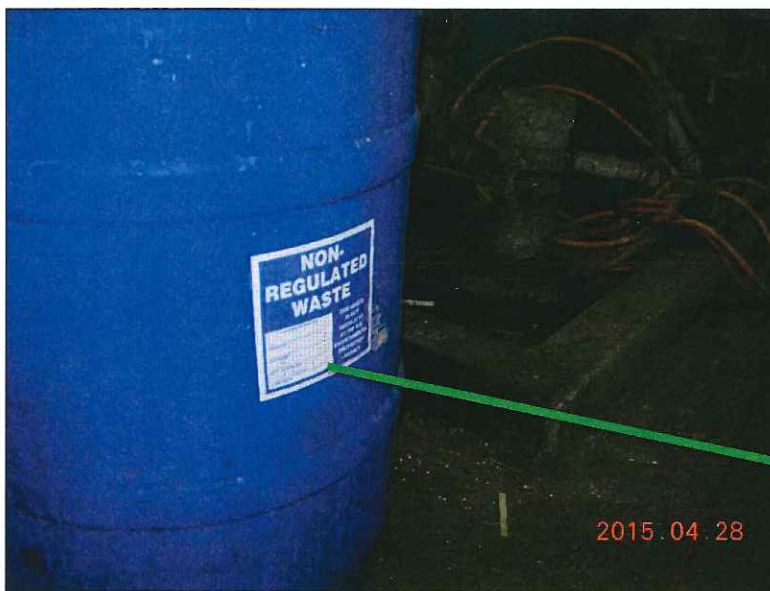
Picture #: 11
(DSCN1158)
Date: April 28, 2015
Photographer: Dan Chachakis
Location: Black Oxide Line
Subject: Container with the words, "Oil Lux"

I observed, and took a picture of, a container with a non-regulated label and the words, "Oil Lux" (Picture 11).

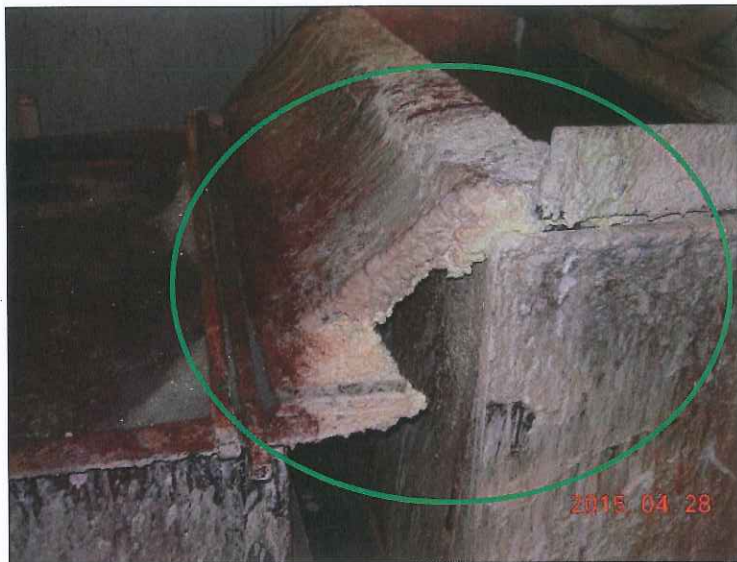
Picture #: 12
(DSCN1159)
Date: April 28, 2015
Photographer: Dan Chachakis
Location: Black Oxide Line
Subject: Sodium Hydroxide

I observed, and took a picture of, a buildup of what Mr. Madden described as sodium hydroxide (Picture 12).

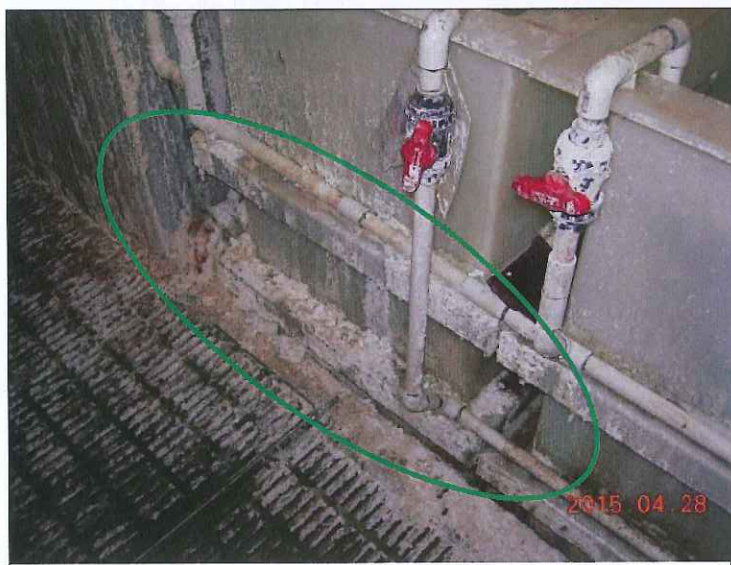
Picture #: 13
(DSCN1160)
Date: April 28, 2015
Photographer: Dan Chachakis
Location: Hand line
Subject: Sodium Hydroxide accumulating on the outside of the process tanks.

Hand line: I observed, and took a picture of, what appeared to be sodium hydroxide accumulating on the outside of the process tanks (Picture 13).

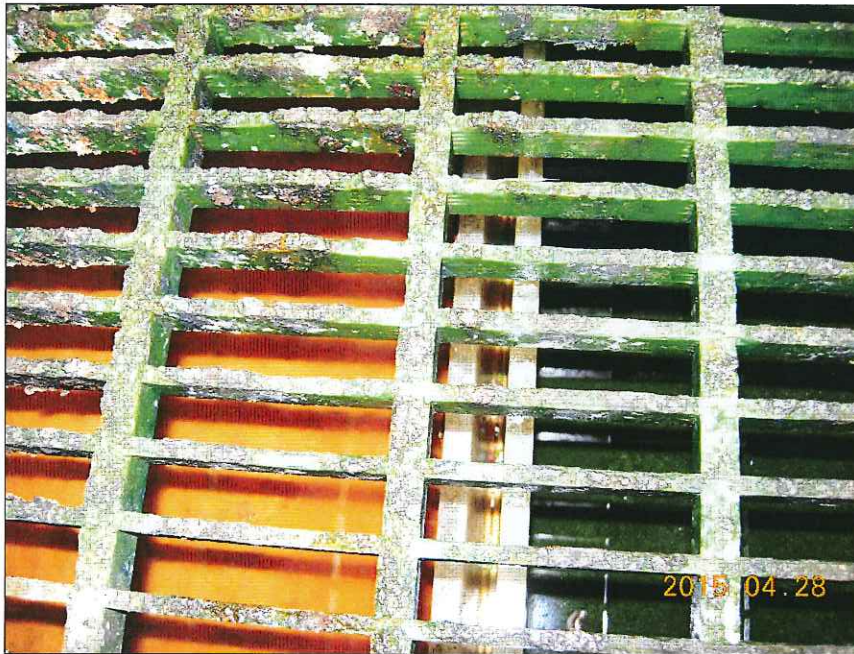
Picture #: 14
(DSCN1161)
Date: April 28, 2015
Photographer: Dan Chachakis
Location: Hand Line
Subject: Brown, yellow and green liquid under walkway.

I observed, and took a picture of, liquid brown/yellow and green in color under the walkway (Picture 14).

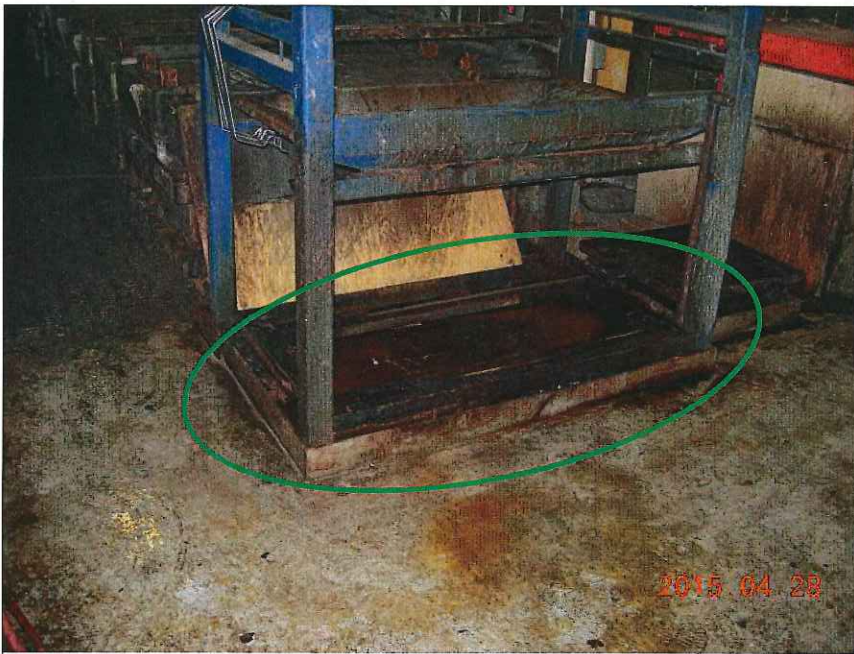
Picture #: 15
(DSCN1162)
Date: April 28, 2015
Photographer: Dan Chachakis
Location: chromate line
Subject: Rinse water

Chromate Line: I observed, and took a picture of, rinse water (Picture 15).

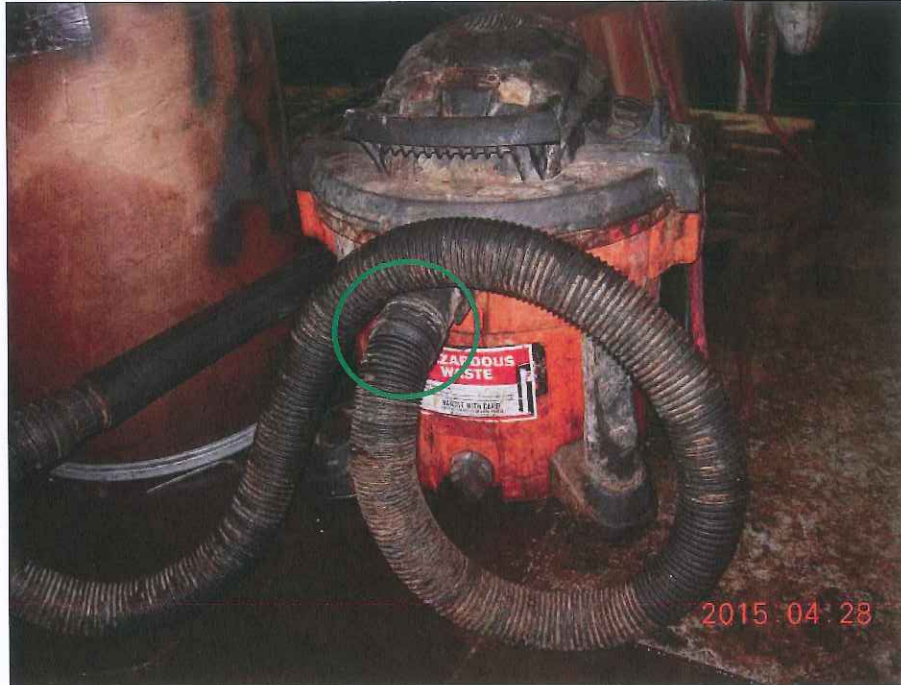
Picture #: 16
(DSCN1163)
Date: April 28, 2015
Photographer: Dan Chachakis
Location: chromate line
Subject: Vacuum

I observed, and took a picture of, a vacuum with a hazardous waste label (Picture 16).

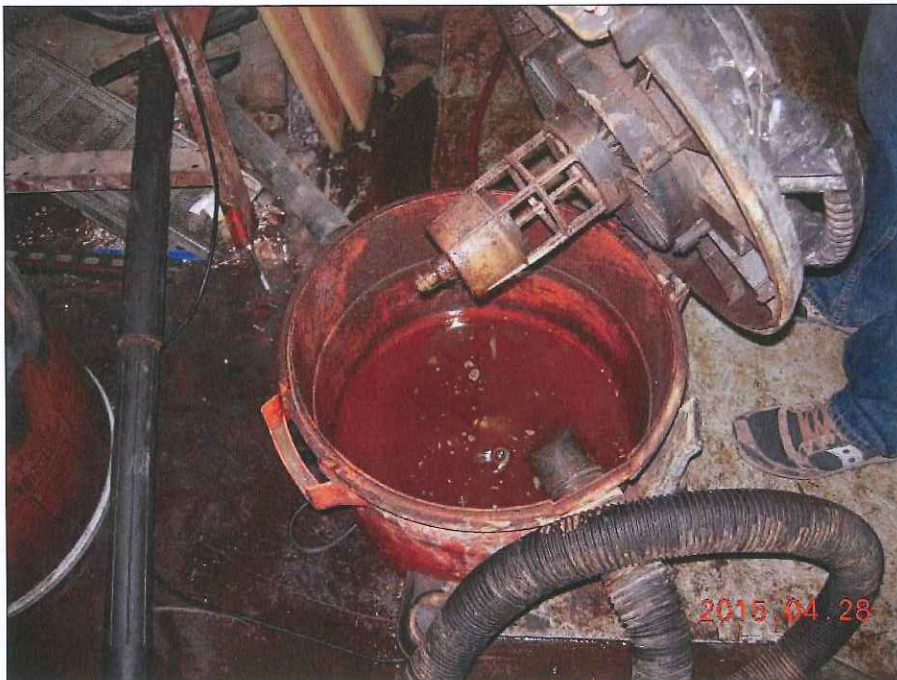
Picture #: 17
(DSCN1164)
Date: April 28, 2015
Photographer: Dan Chachakis
Location: chromate line
Subject: Material in a container

I observed, and took a picture of, material in the vacuum from Picture 16 (Picture 17).

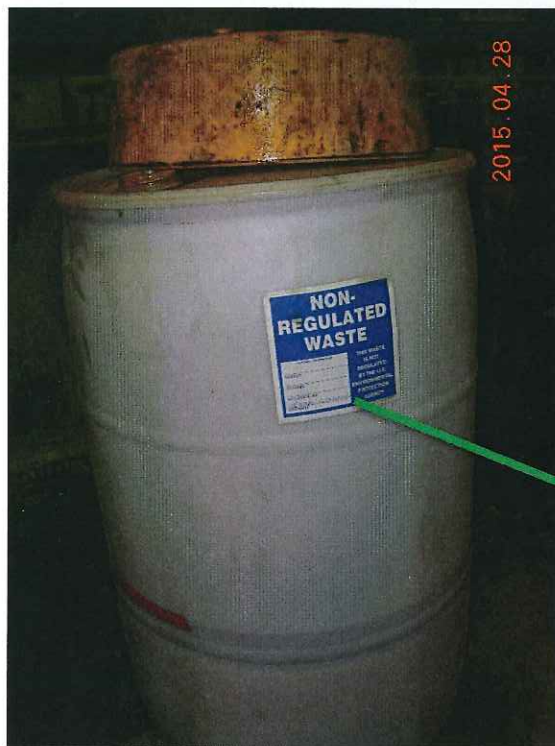
Picture #: 18
(DSCN1165)
Date: April 28, 2015
Photographer: Dan Chachakis
Location: Zinc automatic line
Subject: "Oil Waste"

Zinc Automatic Line: I observed, and took a picture of, a container with a non-regulated waste label marked with the words, "Oil Waste - Auto Trench" (Picture 18).

Mr. Madden stated that material contains hydraulic oil.

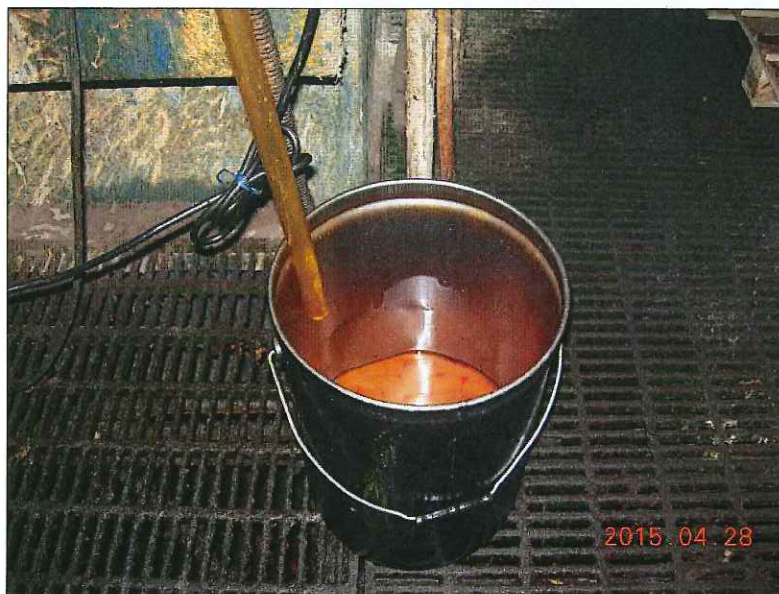
Picture #: 19
(DSCN1166)
Date: April 28, 2015
Photographer: Dan Chachakis
Location: Zinc automatic line
Subject: Material in a container

I observed, and took a picture of, a container without a label or markings describing the contents of the container (Picture 19). Mr. Madden stated the container held used oil.

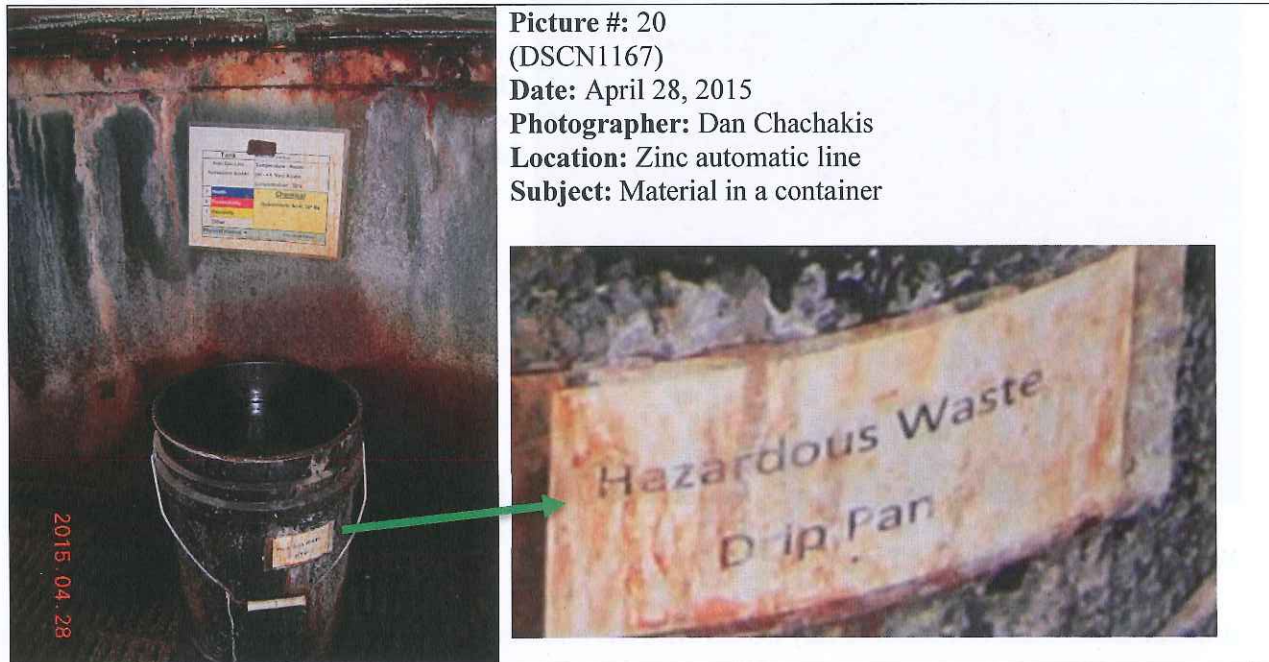
I observed, and took a picture of, a container marked with the words, "Hazardous Waste Drip Pan" (Picture 20). I observed that the container was approximately 80% full.

I observed that the container in Picture 20 was in position to collect drips, and was not closed. I observed, and took a picture of, two open pipe ends above the container in Picture 20 (Picture 21). There may be a requirement for a second container.

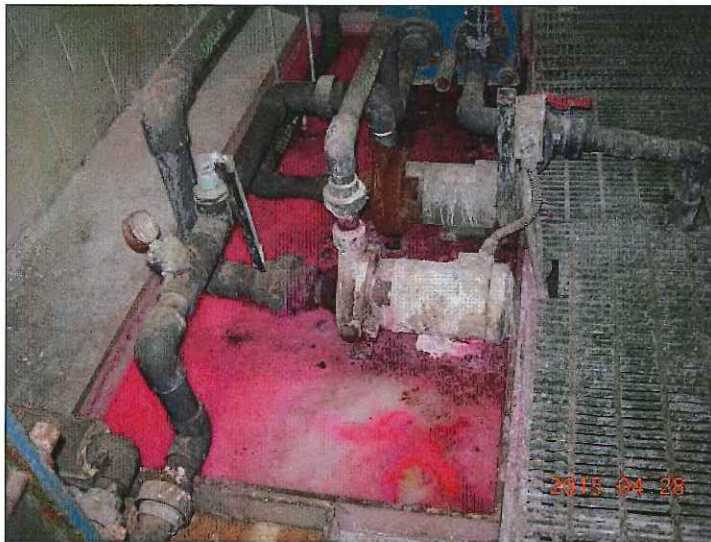
Picture #: 22
(DSCN1169)
Date: April 28, 2015
Photographer: Dan Chachakis
Location: Chiller system
Subject:

Chiller System: I observed, and took a picture of, pink material in the chiller system containment area (Picture 22).

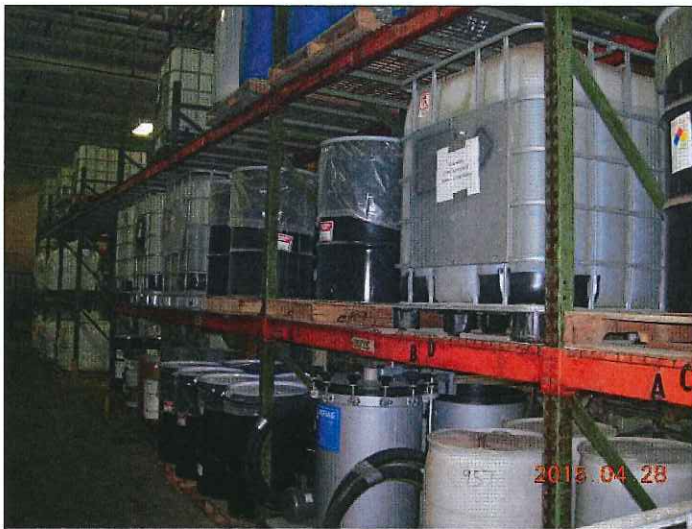
Picture #: 23
(DSCN1170)
Date: April 28, 2015
Photographer: Dan Chachakis
Location: Hazardous Waste Storage Area #1
Subject: Containers on shelf

Hazardous Waste Storage Area #1: I observed, and took a picture of, containers in hazardous waste storage area #1 (Picture 23). I observed that the containers were stacked on three large shelves.

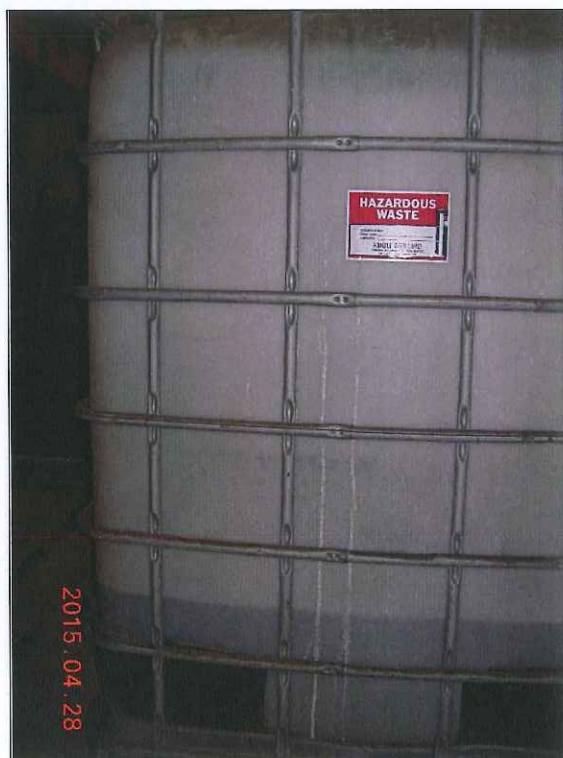
Picture #: 24
(DSCN1171)
Date: April 28, 2015
Photographer: Dan Chachakis
Location: Hazardous Waste Storage Area #1
Subject: Tote

I observed, and took a picture of, a tote with a hazardous waste label, marked with the accumulation start date, "4-13-15" and the words, "Nitric Acid" (Picture 24). Note: the flash from the camera washed out the writing on the label.

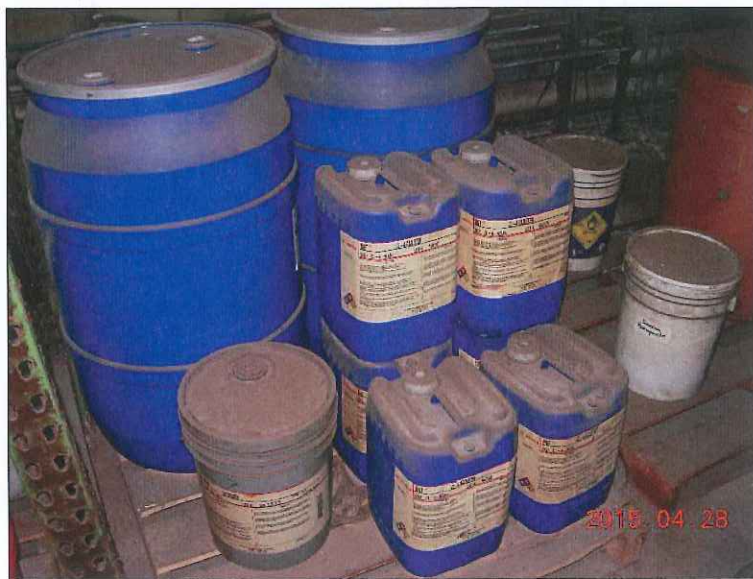
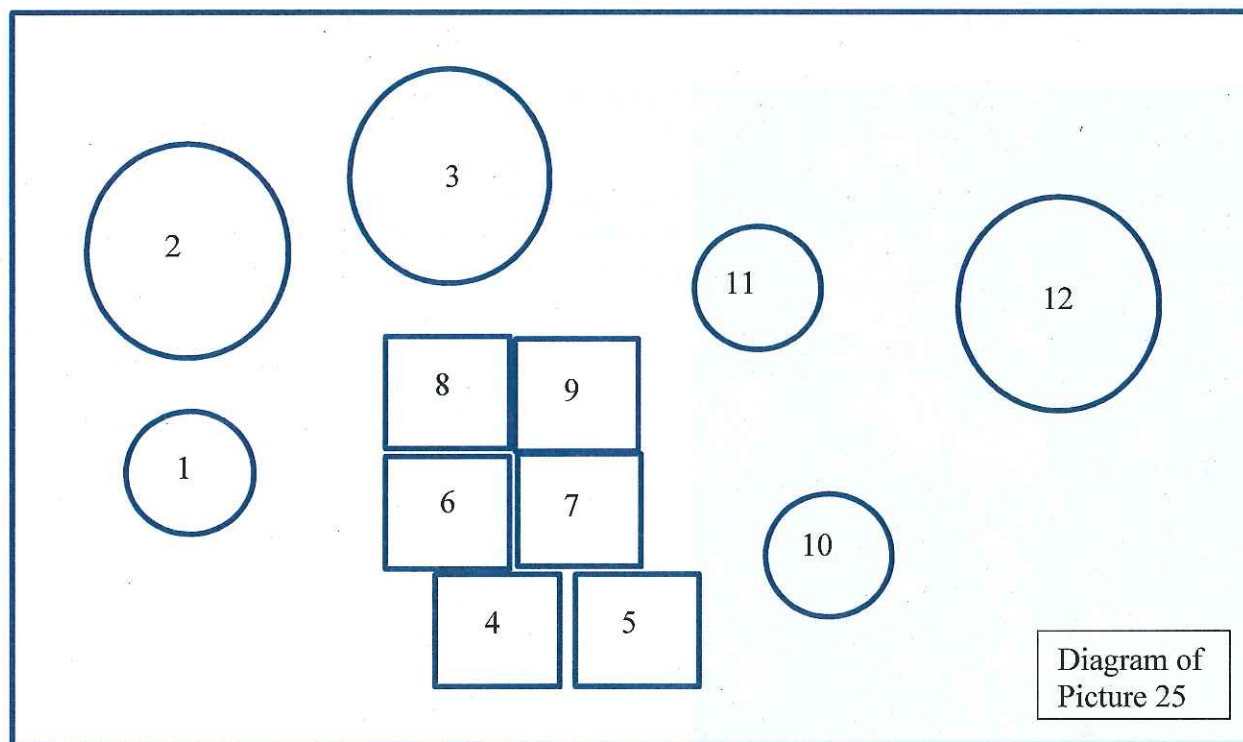
Picture #: 25
(DSCN1172)
Date: April 28, 2015
Photographer: Dan Chachakis
Location: Hazardous Waste Storage Area #1
Subject: Lower shelf of chemicals not in use

I observed that the shelf contained containers of chemicals. Mr. Madden stated that the chemicals were no longer in use, and had not been in use for over a year. I took three pictures of these chemicals; the lower shelf (Picture 25), the middle shelf (Picture 26), and the top shelf (Picture 27).

I diagramed and recorded information from the containers in Picture 25.

Contents of Picture 25 and Diagram of Picture 25		
#	Name on label	Comments by facility personnel
1	Extender GP50BR	Lot # 081902
2	Sodium Thiosulfate	Occasional use
3	Sodium Acetate	Occasional use
4	CL-4 Adjuster	No comments
5	CL-4 Adjuster	No comments
6	CL-4 Adjuster	No comments
7	CL-4 Adjuster	No comments
8	CL-4 Adjuster	No comments
9	CL-4 Adjuster	No comments
10	Potassium Permanente	In use
11	Potassium Permanente	In use
12	Acid salt	In use

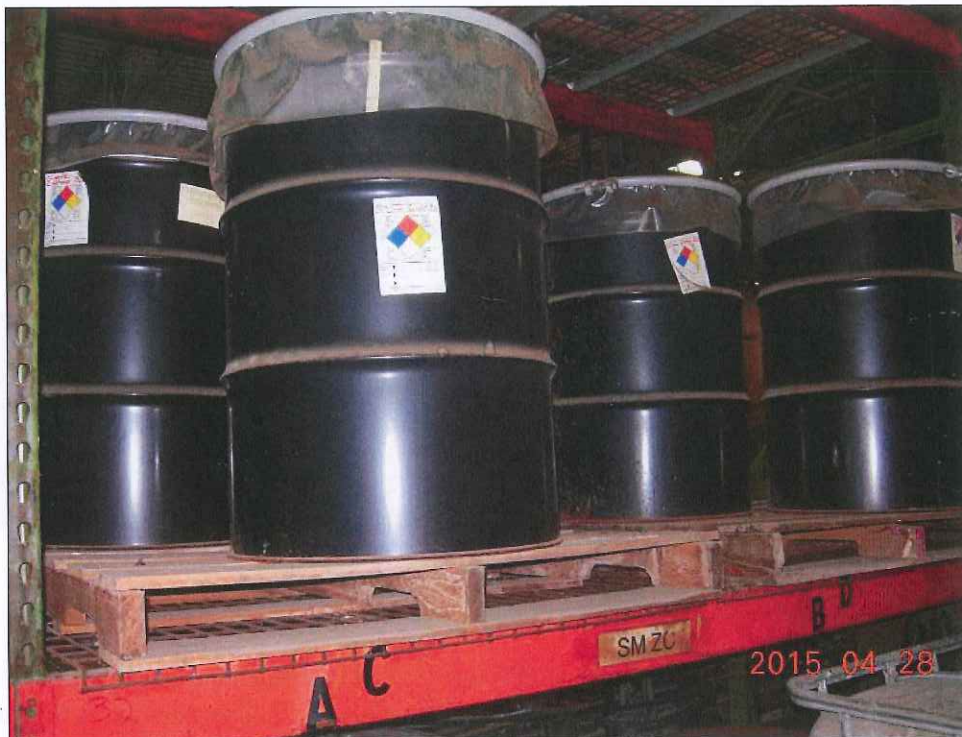
Picture #: 26
(DSCN1173)
Date: April 28, 2015
Photographer: Dan Chachakis
Location: Hazardous Waste Storage Area #1
Subject: Middle shelf of chemicals not in use

Mr. Madden stated that the second and third rows, Pictures 26 and 27, respectively, contained cleaners in use.

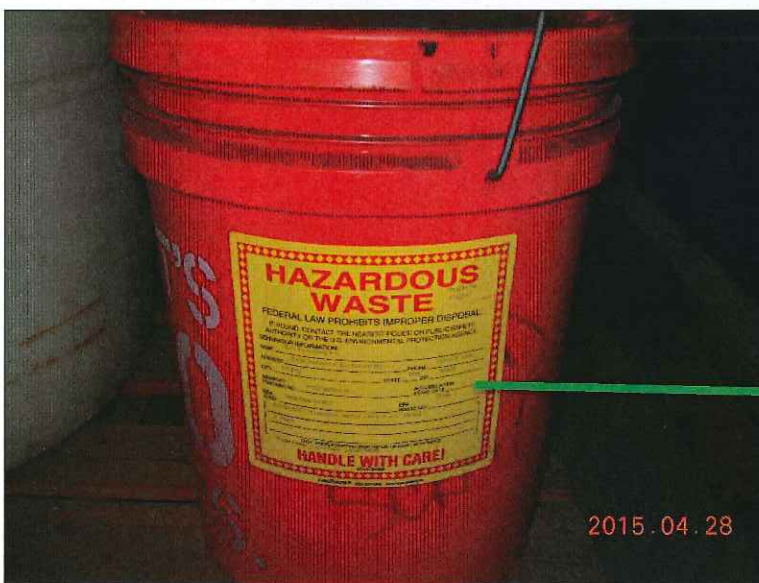
Picture #: 28
(DSCN1175)
Date: April 28, 2015
Photographer: Dan Chachakis
Location: Hazardous Waste Storage Area #1
Subject: Container, second row, bottom shelf

I observed, and took a picture of, a container in the 2nd row, bottom shelf (Picture 28). I observed that there was no accumulation start date marked on the label or elsewhere on the container. Mr. Madden had staff correct this error, and the container was marked with the accumulation start date of 4/6/2015.

At the time of the inspection, one pail of D008 hazardous waste in the less-than 90 day hazardous waste storage area #1 was not marked with an accumulation start date. Facility personnel added the accumulation start date to the label at the time of the inspection. At the time of the inspection, one tote of F006 hazardous waste under a filter press was not marked with the accumulation start date. Facility personnel added the accumulation start date to a label, and then affixed the label to the tote at the time of the inspection.

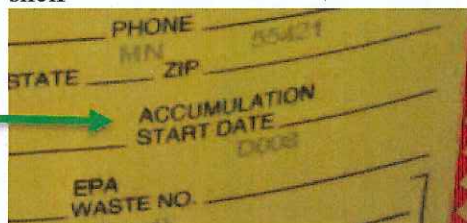
Picture #: 29
(DSCN1176)
Date: April 28, 2015
Photographer: Dan Chachakis
Location: Hazardous Waste Storage Area #1
Subject: Container, second row, middle shelf

I observed a container in the second row, middle shelf (Picture 29). I recorded the hazardous waste label was marked with the accumulation start date of, "3-3-15", and the words, "E-less trench / zinc waste."

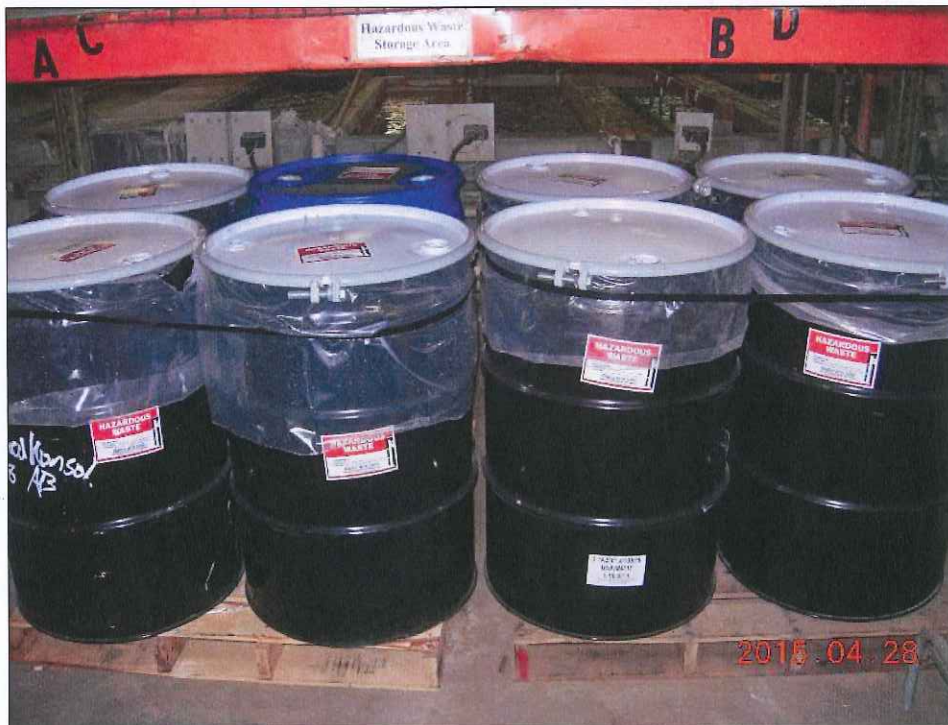
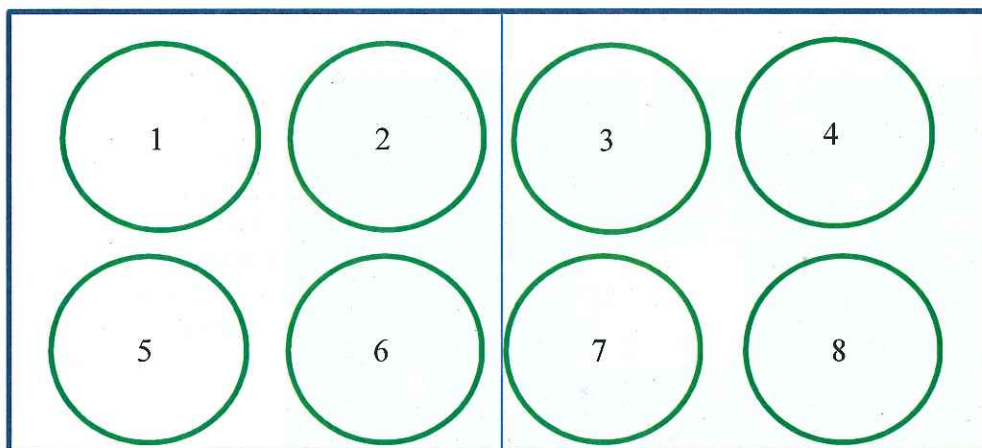
Picture #: 30
(DSCN1177)
Date: April 28, 2015
Photographer: Dan Chachakis
Location: Hazardous Waste Storage Area #1
Subject: Containers, third row, bottom shelf

I observed, took a picture of, and diagramed the third row, bottom shelf (Picture 30).

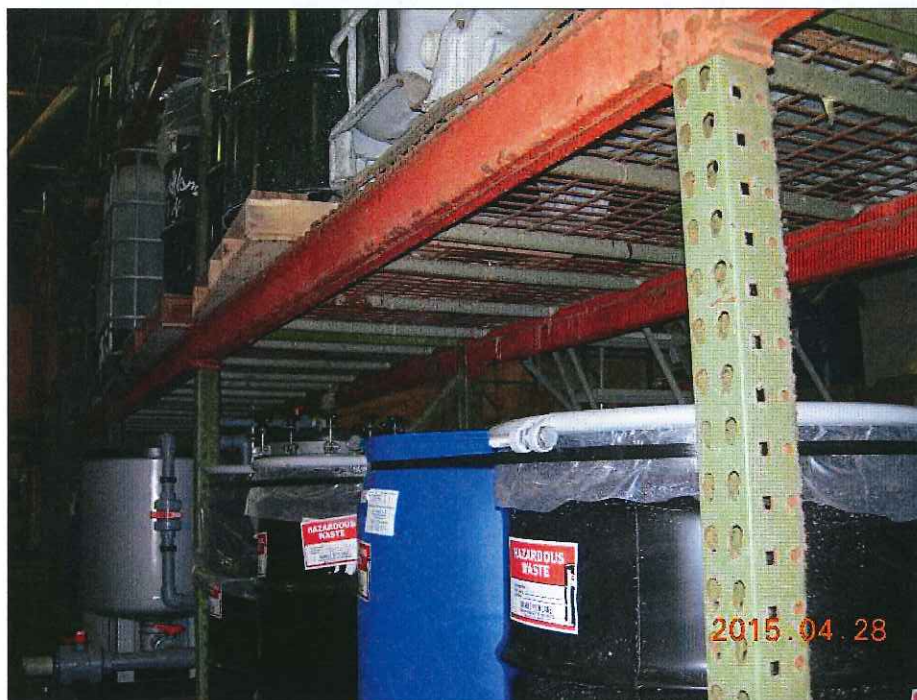
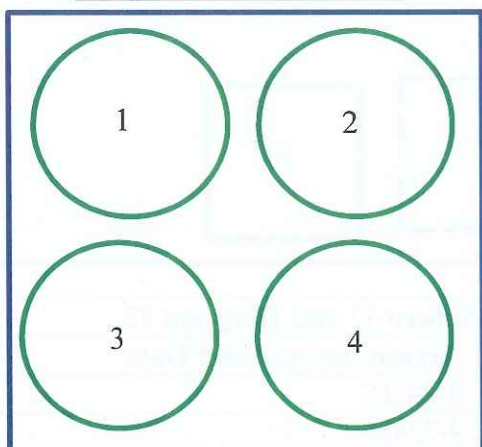
Picture #: 31
(DSCN1178)
Date: April 28, 2015
Photographer: Dan Chachakis
Location: Hazardous Waste Storage Area #1
Subject: Containers, third row, bottom shelf, back-side

I observed, and took a picture of, the third row, bottom shelf, backside (Picture 31).

Contents of Picture 31 and Diagram of Picture 31		
#	Accumulation start date	Contents of containers
1	02/09/15	Mag Pans Sludge
2	1/29/15	Nickel waste*
3	4/5/15	Mag Phos sludge
4	4/5/15	Mag Phos sludge

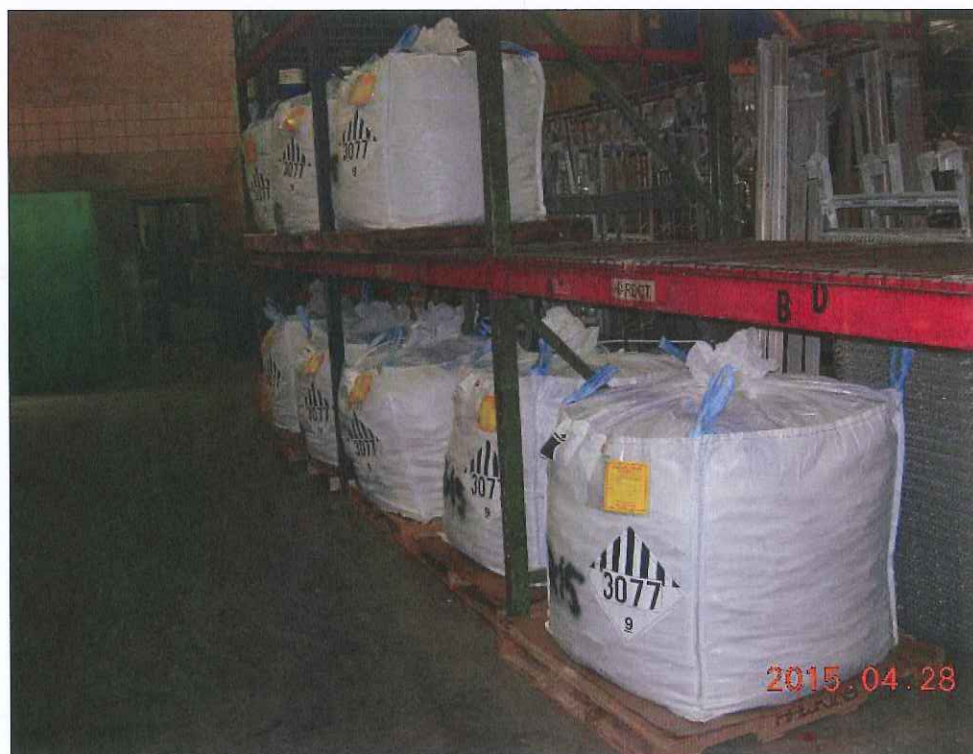
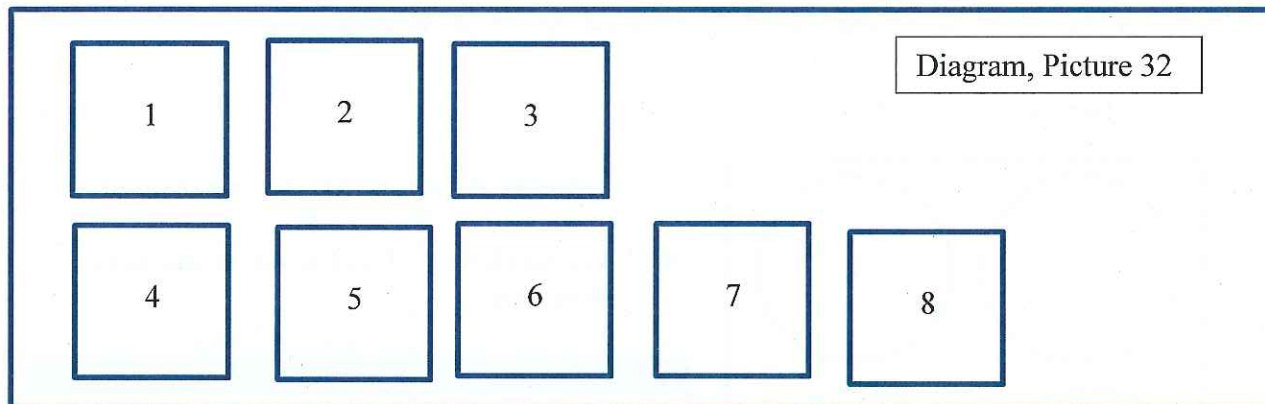
Picture #: 32
(DSCN1179)
Date: April 28, 2015
Photographer: Dan Chachakis
Location: Hazardous Waste Storage Area #1
Subject: Hazardous Waste Tote storage area

I observed, and took a picture of, the hazardous waste tote storage area (Picture 32). I observed that each had a hazardous waste label, and each was marked with the characteristic "F006."

Accumulation Start Dates for Totes in Picture 32 and Diagram 32			
#	Accumulation State Date	#	Accumulation Start Date
1	4-25-15	5	4-24-15
2	4-27-15	6	4-23-15
3	4-27-15	7	4-23-15
4	4-25-15	8	4-22-15

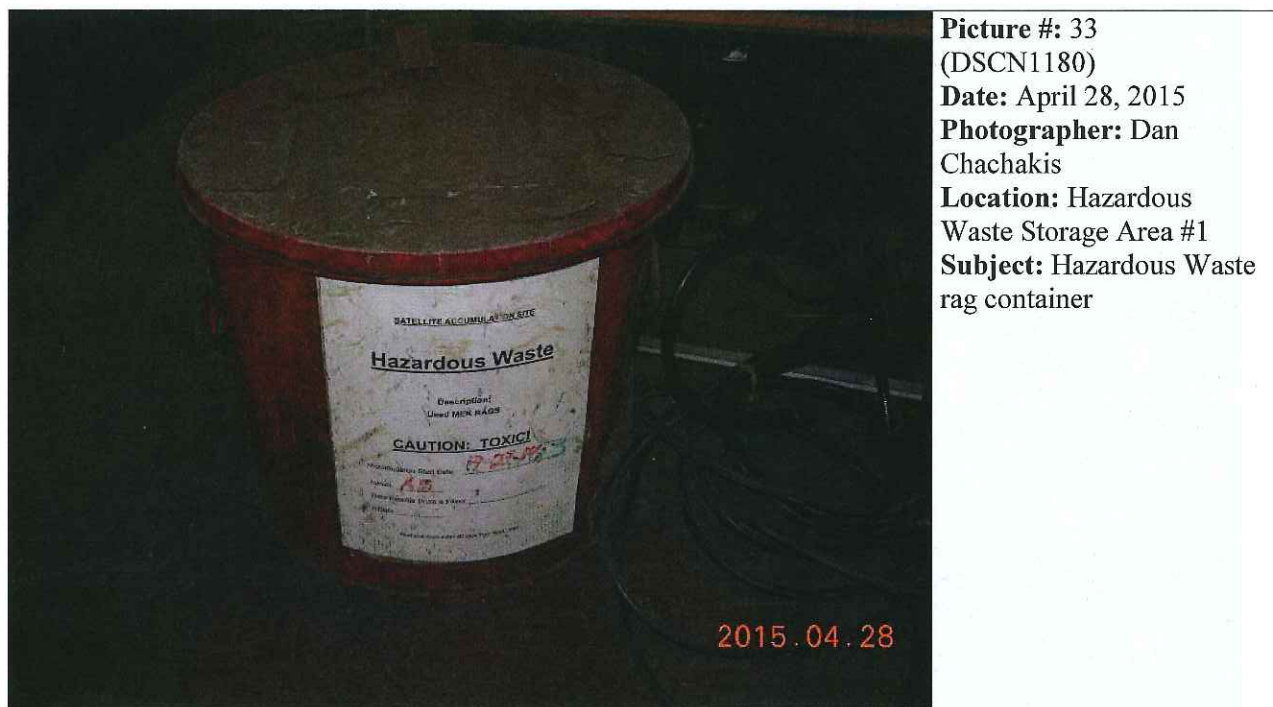
I observed, and took a picture of, a hazardous waste rag container (Picture 33).

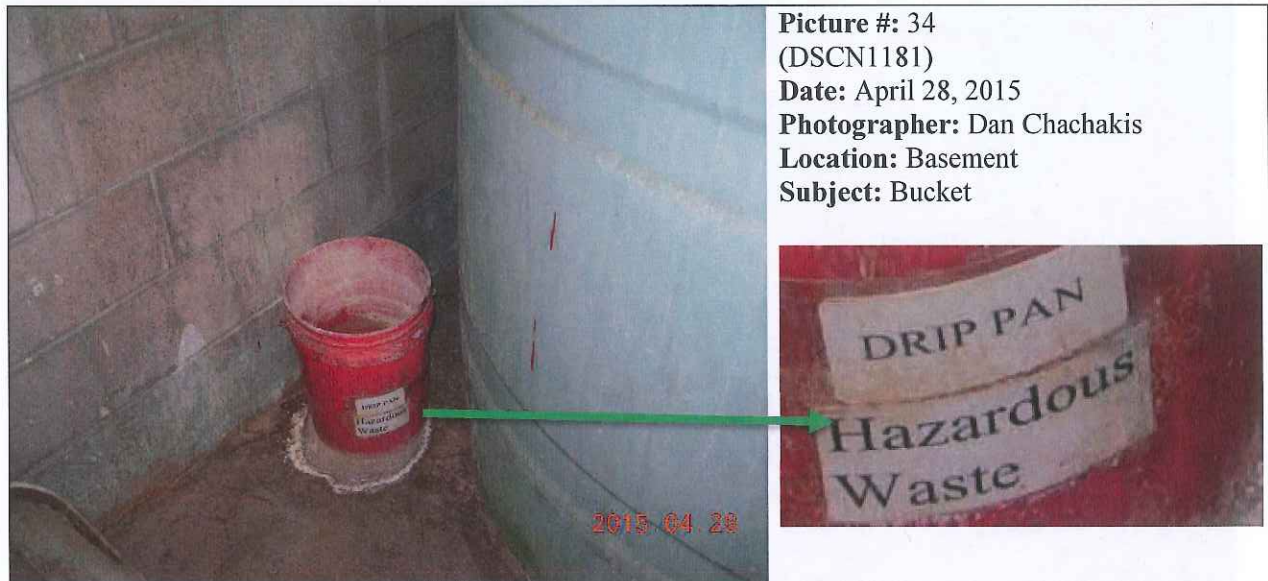
Picture #: 34
(DSCN1181)
Date: April 28, 2015
Photographer: Dan Chachakis
Location: Basement
Subject: Bucket

I observed, and took a picture of, a pipe above a bucket (Picture 34). Mr. Madden stated the bucket contained waste cyanide.
